**Service Advisory**  
Date: December 2011

**SCISSOR ARM PIVOT PINS – INSPECTION**  
**APPLIES TO: ALL SKYJACK SCISSOR LIFT MODELS**

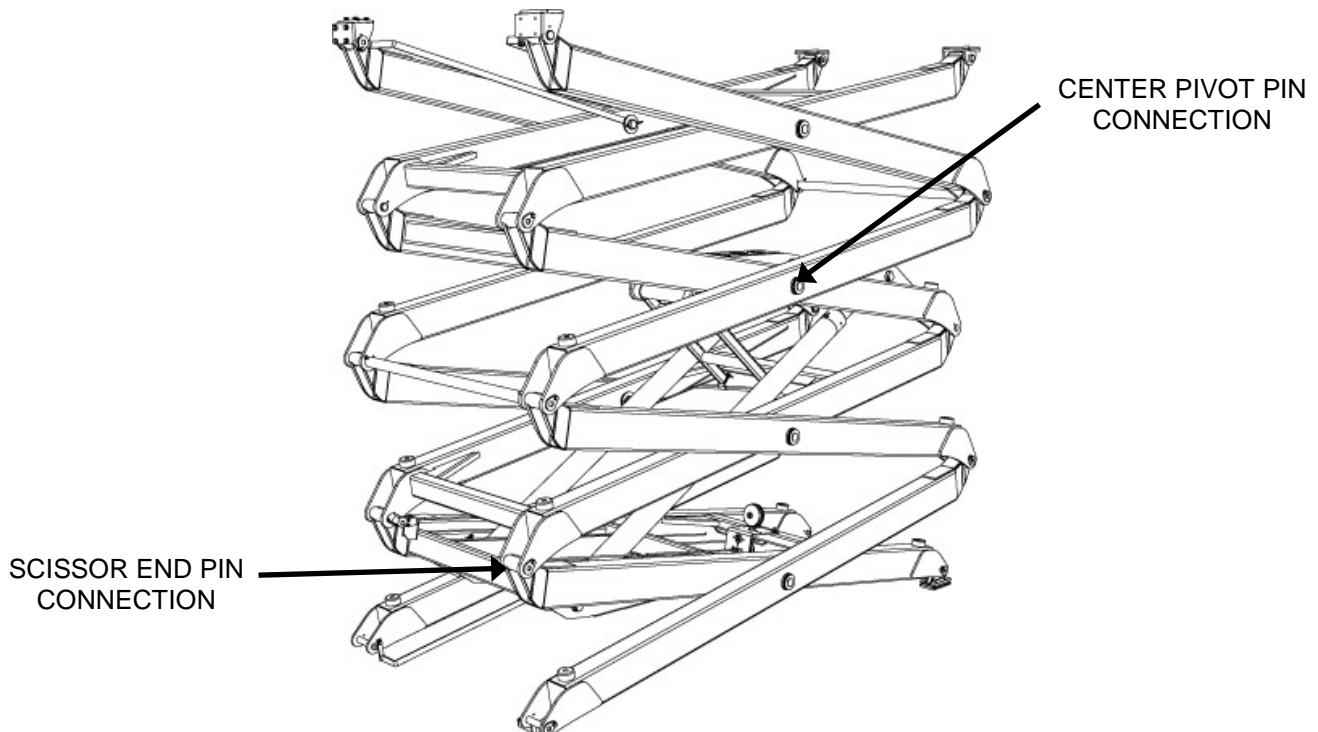
On all scissor assemblies, the scissor arm end pins and center pins (see Figure 1) must be regularly inspected for signs of damage or excessive wear. **Failure to inspect and properly maintain pinned connections can lead to scissor arm failure and assembly collapse, potentially causing serious injury and/or death.**

**Figure 1: Scissor assembly showing pin connection points**

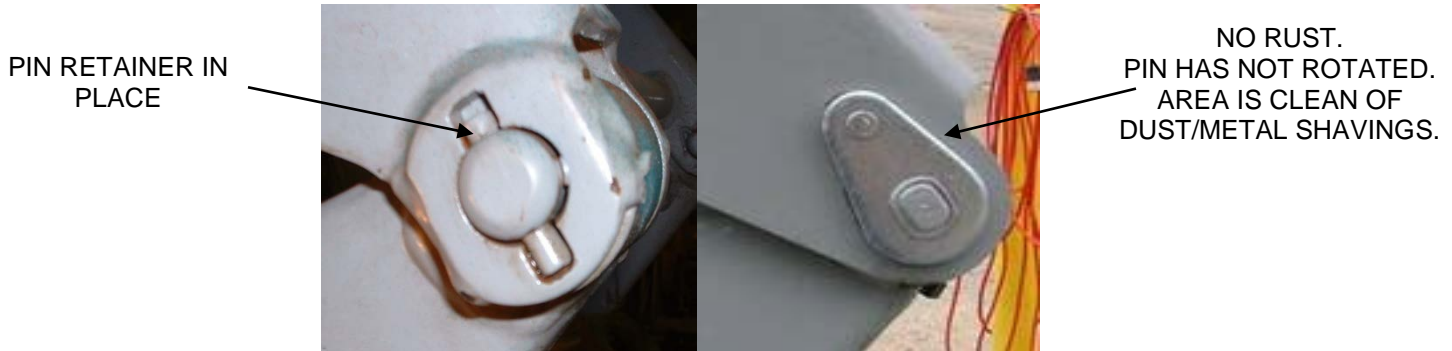
**Figure 2: Scissor end pin connection - no evidence of damage**

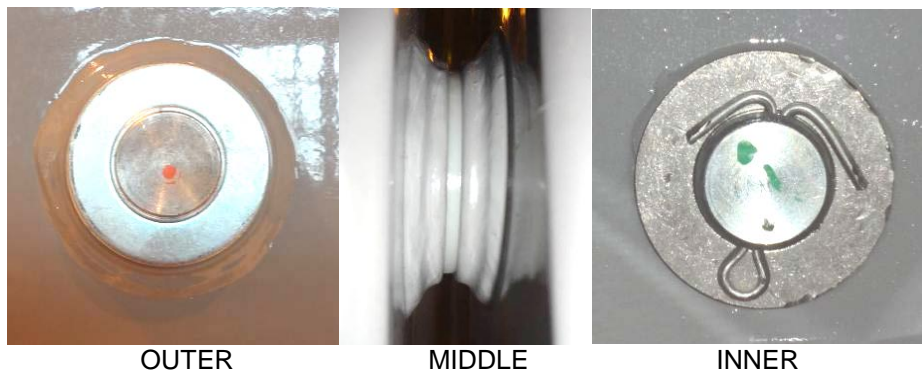
**Figure 3: Center pivot pin connection – no evidence of damage**

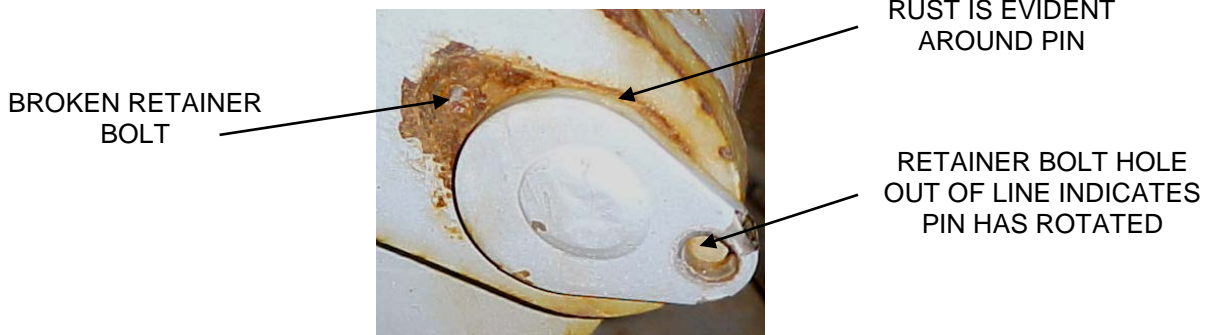
**Figure 4: Scissor end pin connection - damaged**

Scissor end pin connections showing symptoms of damage must be inspected after removing the applicable pins and bushings. The scissor bore should also be inspected at this time for any signs of damage, specifically elongation or ovality of the hole. Provided there is no structural damage to the scissor arms, the pins and bushings can be replaced with new components.

Any units with structural damage to any pin connection or scissor arm must be **immediately removed from service** and repaired by a qualified technician. Contact Skyjack Service for direction on how to repair the unit.

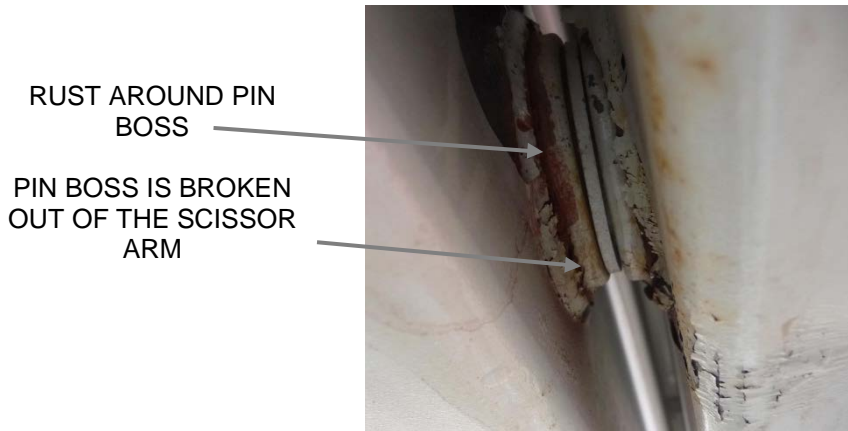
**Figure 5: Center pivot pin connection – damaged**
