TECH TIP DECEMBER 2024 ROUGH TERRAIN SCISSOR GP MODULES

The Skyjack Rough Terrain scissor lifts (SJ7127/35, 8841, & 9250 models) utilize a GP106 control module for the auto level outrigger function. The newer ANSI models (SJ6826/32 with the 'A' serial numbers) use both a GP106 (Auto Level/Outriggers) & GP102 (Load sensing). The GP108 module is a replacement for the GP102 and the GP106.

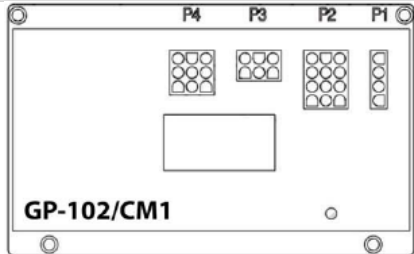
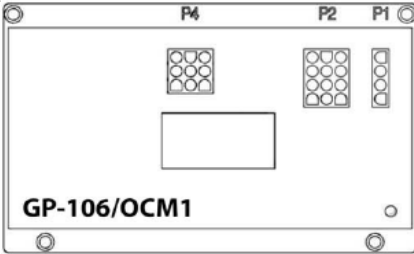
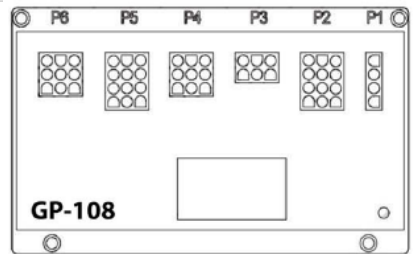
GP102 LOAD SENSING		GP106 OUTRIGGER		GP108 O/R & LOAD SENSE

Use the correct service manual for the serial number of the unit you are working on is the first step. Then, identify the GP module you have. Each module has a different amount of harness connectors on its front. The picture below is a partial example of the chart found in service manual. You will also find more testing and programming information in section 5 of the manual.
